QA-103
Fishingham
Centreville vicinity
Private

# INVENTORY FORM FOR STATE HISTORIC SITES SURVEY

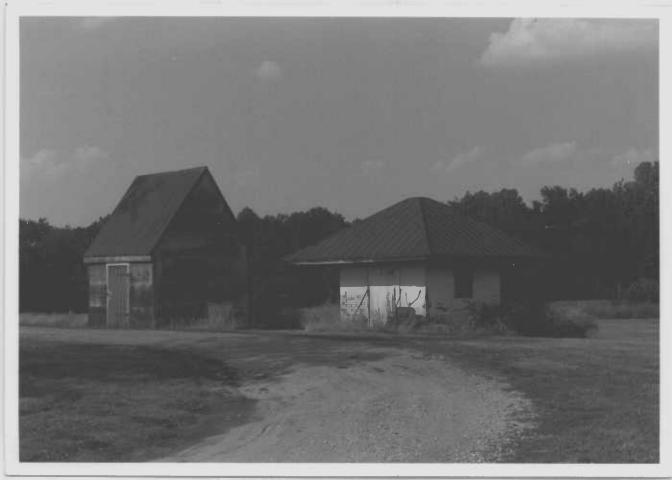
QA103

Fishingham
Meathouse (4)
Dairy (R)
